USA-BRDEC-TR // 2513

# Improved Ribbon Bridge (IRB) Prototype Transporter— Operational Test

Report Date
May 1992

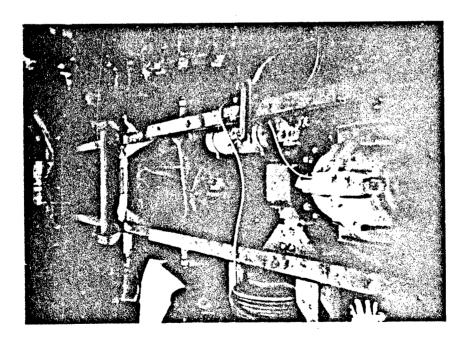
Photo 4. Brackets have been mounted onto the HEMTT so that the LHS will clear the differential

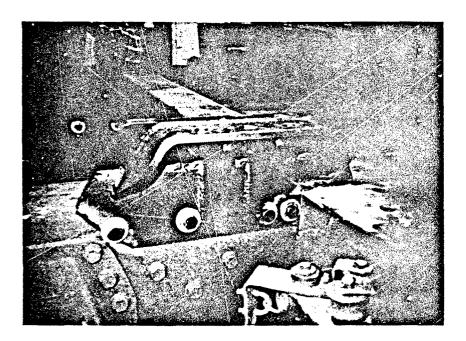
Photo 7. The rear mounting bracket of the LHS had to be cut so that the winch cable guide could be mounted

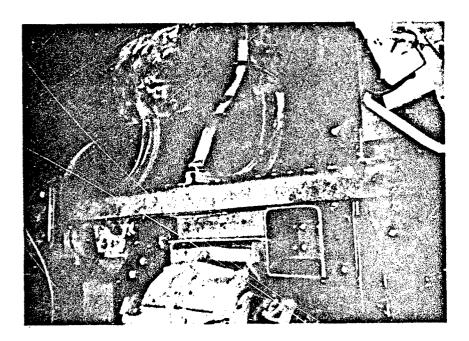
Photo 8. The fuel tank was removed so that the LHS mounting brackets could be bolted to the frame

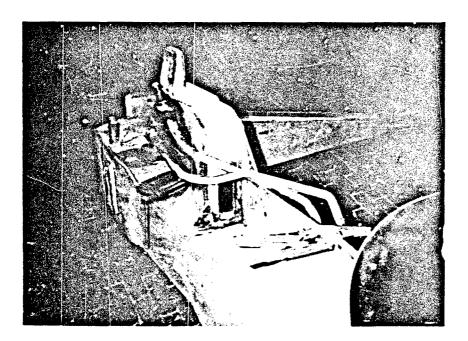
Photo 11. A passageway was cut in the hook arm to route hydraulic lines

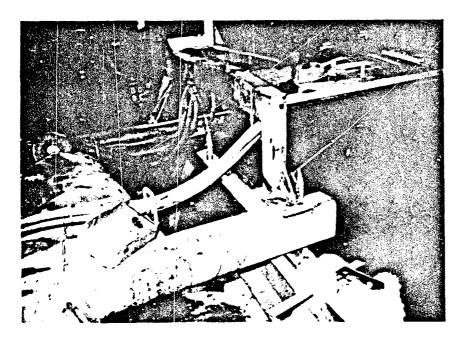
Photo 12. The hydraulic control box and mountings were moved 4 inches to the left and rewelded

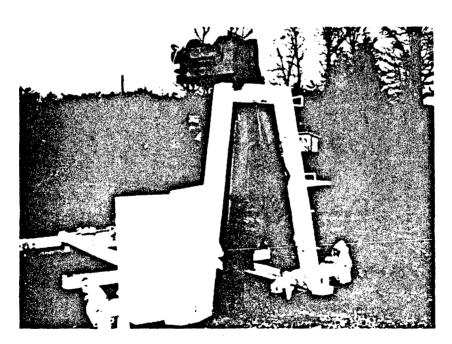
Photo 20. The two bottom rungs of the ladder and the left side storage box were removed due to inteference

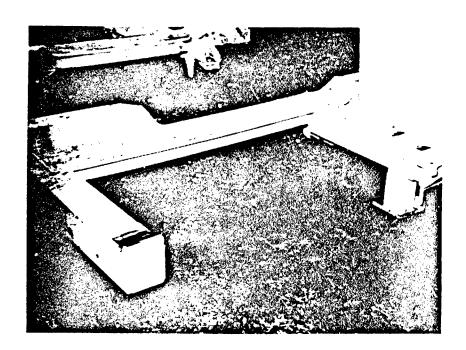
Operational and design deficiencies were noted during the test, and modifications were made to eliminate some of the problems where possible. Lowering the BAP frame rails to provide clearance with the bay was the major change. The prototype Transporter tested had not been modified to Interface with the Ribbon Bridge Erection Boat (RBEB) and Boat Cradle, and the Cargo Pallet. Future Transporters will be capable of transporting the fielded Ribbon Bridge bays, the PLS Flatrack, the RBEB and Cradle, fielded Cargo Pallet, and the IRB. A Contract Task Order (0015) has been issued to VSE (DAAK70-90-D-0001) to provide four future Transporters and BAPs which will accomplish all of these operations.

Photo 21. The front frame rails were cut and lowered to provide clearance with the lever arms (see Photo 22 for interference)

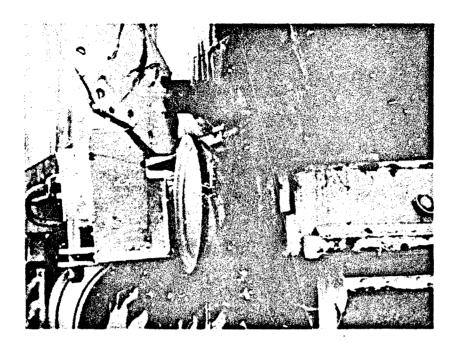
In order to throw the front roadway-to-roadway latch, the bay had to be control-launched approximately 8 inches so that the latch could be engaged. This was due to a stop block that was located on the winch frame of the BAP (photo 22). Due to its position, there was insufficient room to engage this latch. After engaging the latch, the bay was brought back down and free-launch preparations were completed.

- In order to disengage the front roadway-to-roadway latch, the bay had to be control-launched approximately 8 inches so that the latch could be disengaged. This was due to a stop block that was located on the winch frame of the BAP (photo 22). Due to its position, there was insufficient space to disengage this latch. After disengaging, the bay was brought back down and free-launch preparations were completed.

Photo 22. The roadway to roadway latch could not be thrown because it intefered with the stop block on the winch frame

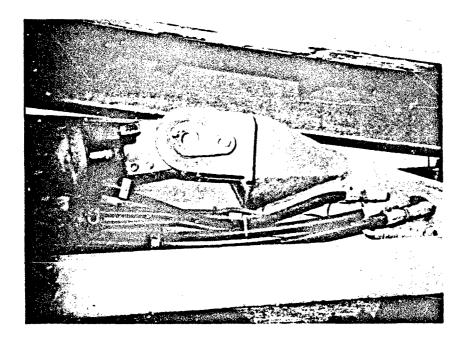
There were no problems encountered during testing with the exception that if the system was operated at idle speed, in the automatic mode, the Flatrack did not lock down in the rear. This was due to an electronic sensor located on the LHS. If the system is operated slowly, the middle frame will not fully retract before the hook arm starts to come in. This causes the rear of the Flatrack to not lock in place. The problem was corrected by operating the LHS at high idle or retrieving the middle frame manually before the hook arm was retracted.

During testing with the PLS Flatrack, it was noted that the Flatrack would not properly lock down onto the Transporter if the LHS was operated at idle speed in the automatic mode. The cause was determined to be because a proximity switch on the LHS allowed the hook arm to begin retracting before the middle frame had completely retracted. This did not allow the rear of the Flatrack to fasten. Retrieving the Flatrack at high idle speed or bringing the LHS arms in manually eliminated this problem.

Photo 27. The electronic sensor has prevented the middle frame from fully retracting

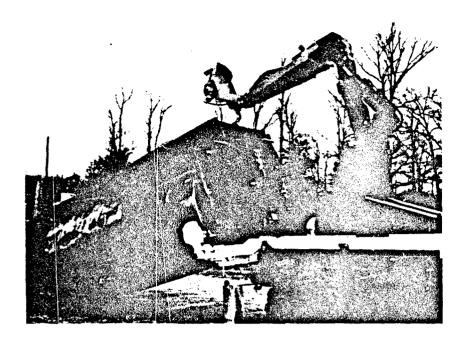
Photo 39. The bay is interfering with the rear rollers and bay guide because the hook arm is extended too far

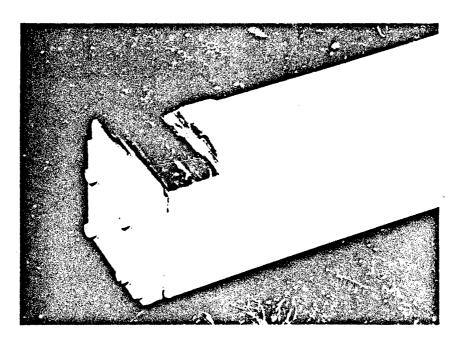
Free-launching the ramp and interior bays was accomplished with little trouble during the trials (photos 45, 46, and 47). The outerfront resting pads on the BAP exhibited some wear due to the free-launching, but did not seem to affect operations (photo 48). The use of rollers instead of wear pads would improve launching if rollers were designed and incorporated. The lanyard required a greater effort to release during testing; however, this was due to the lanyard mechanism. After adjustment, the lanyard release was improved.

Photo 48. The front resting pads were worn by launch and retrieval

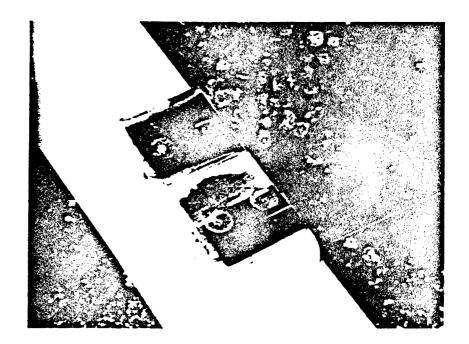
Photo 49. The center slide pad was worn by the ramp bay

- The hook arm has to be extended out further when the ramp bay is launched (8 to 10 inches) due to the center of gravity of the bay. If rollers were added to the middle supports, launching of the bays would improve and the wear pads on these supports would not become worn.

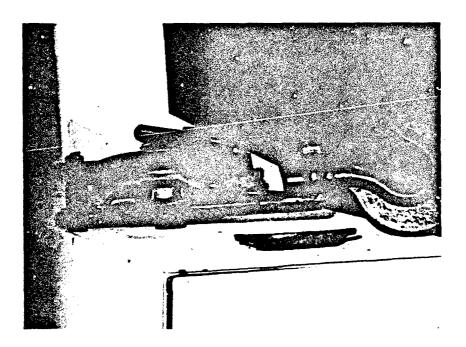
One other problem noted during the high bank launch was with the snatch block. Once, the winch cable was brought in too far and the hook assembly damaged the wheel on the snatch block (photo 55). Although the setup was still operational, a "caution" for this should be put in the manuals.

Photo 55. The suatch block was damaged when the cable was winched in too far

One other problem noted during the high bank launch was with the snatch block. Once, the winch cable was brought in too far and the pulley on the snatch block (photo 55) was damaged. Although the system was still operational, a "caution" for this should be put in the manuals.

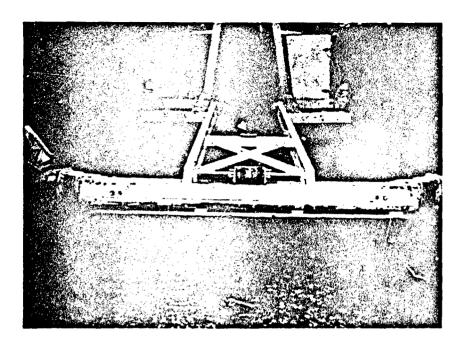
Photo 57. There is a gap between the rear bumper and the ground support on the rear of the BAP
